DuraStop®

Solving Noise-Related Concerns

Follow these procedures to greatly reduce brake noise...
Greatly increasing customer satisfaction!

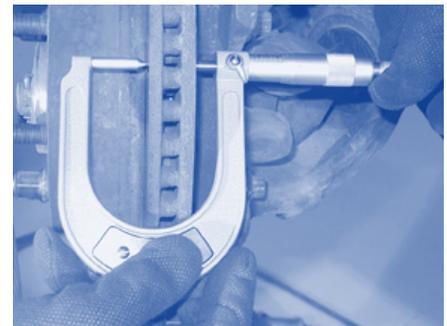
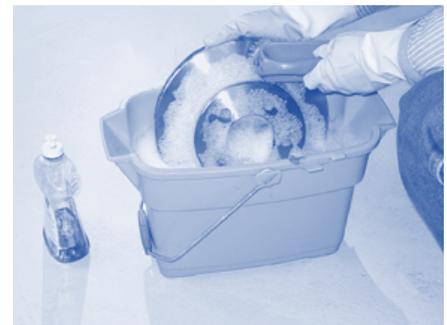
1. **New DuraStop rotors DO NOT need machining.** If the used rotors will meet thickness and condition specifications:

- A. Machine rotors making sure the lathe is clean, within specs and has sharp tool bits.
- B. After completing the finish cut, sand both sides of the rotor for one minute per side using a sanding block and 130 to 150 grit sandpaper, obtaining a non-directional finish.
- C. After sanding, wash the rotor with dish soap and water. **DO NOT clean the rotor with brake cleaner/solvent-based product.**

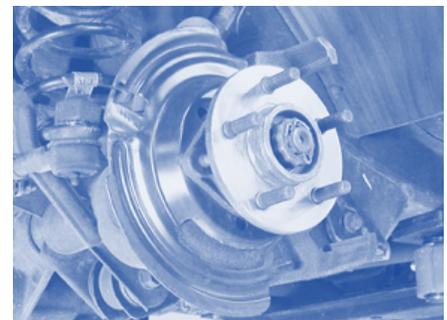
2. Thoroughly clean the calipers, caliper slides and hardware. Remove all dirt, rust and grease.

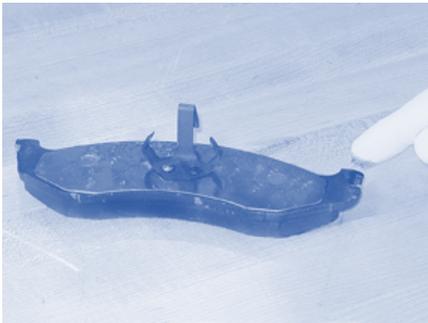
3. Lubricate caliper slides, shims and rubber components:
Only use ACD# 89021537 (10-4022) silicone-based lubricant or equivalent before installation.
ACD# 89021537 (10-4022) is rated at 2000°F.
DO NOT use a *petroleum-based* or spray adhesive product.

- A. Lubricate all hardware rubber components and all metal-to-metal contact points.
- B. Give caliper slides and disc pad shims/insulators a thin film of lubricant. This will allow the shim to withstand normal brake pad movement without damage to the shim. Additionally, this helps dampen vibration... a contributor to brake noise.

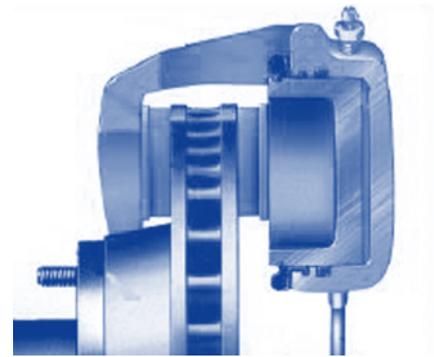
4. Make sure the disc pads are tight in the caliper and torque the caliper to the housing.

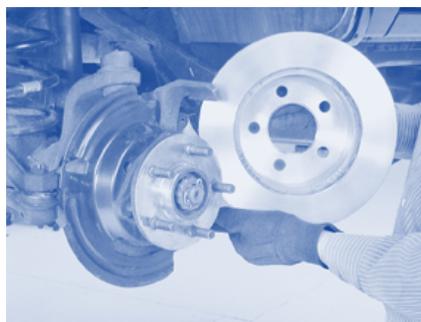
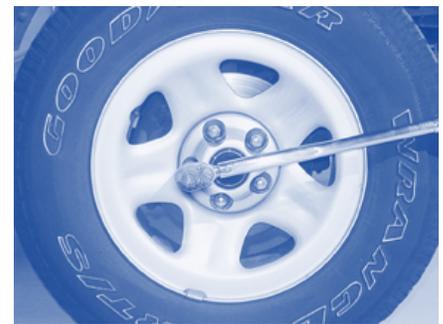
6. After cleaning all wheel-hub mating surfaces, install the wheels. **Make sure they are torqued to manufacturer's specifications.**

A torque wrench is preferred. A calibrated "TorqStick" is allowed.
